**Pergam Technical Services, Inc.**  
**SELMA**  
**Inspection Report**

MPB6

Customer:  
Test

Inspection Date: 15.05.2015

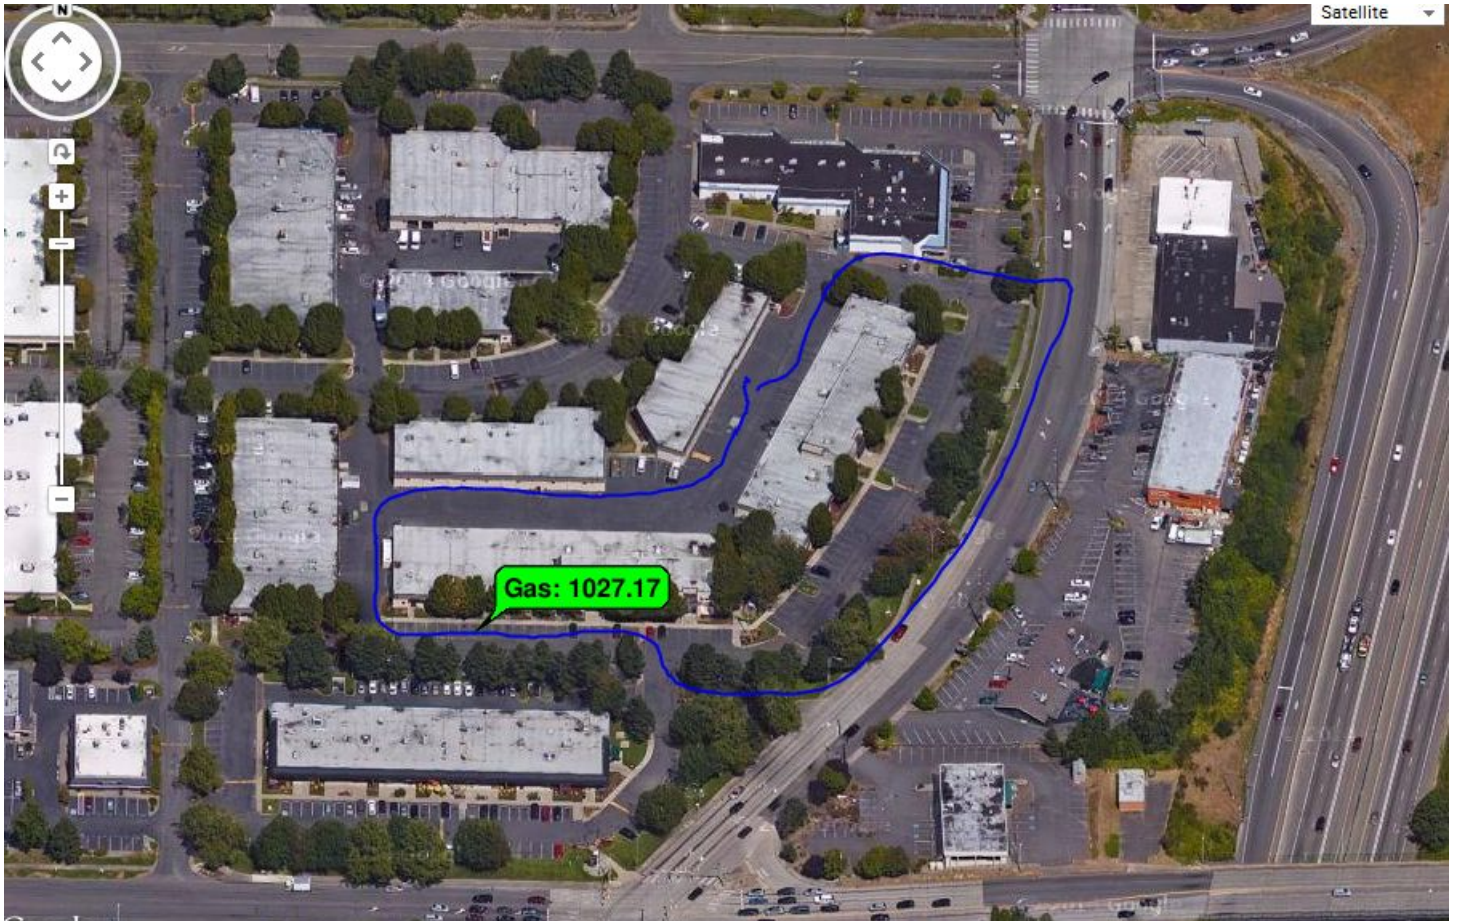
Main map:

Total Distance: 0.571 km

<b>Detection</b>	<b>Time</b>	<b>Latitude</b>	<b>Longitude</b>	<b>Maximal vechicle speed, km/h</b>	<b>Maximal gas concentration, ppm</b>
1	10:48:32.91	47.4419200	-122.2204400	13.6	1027.17

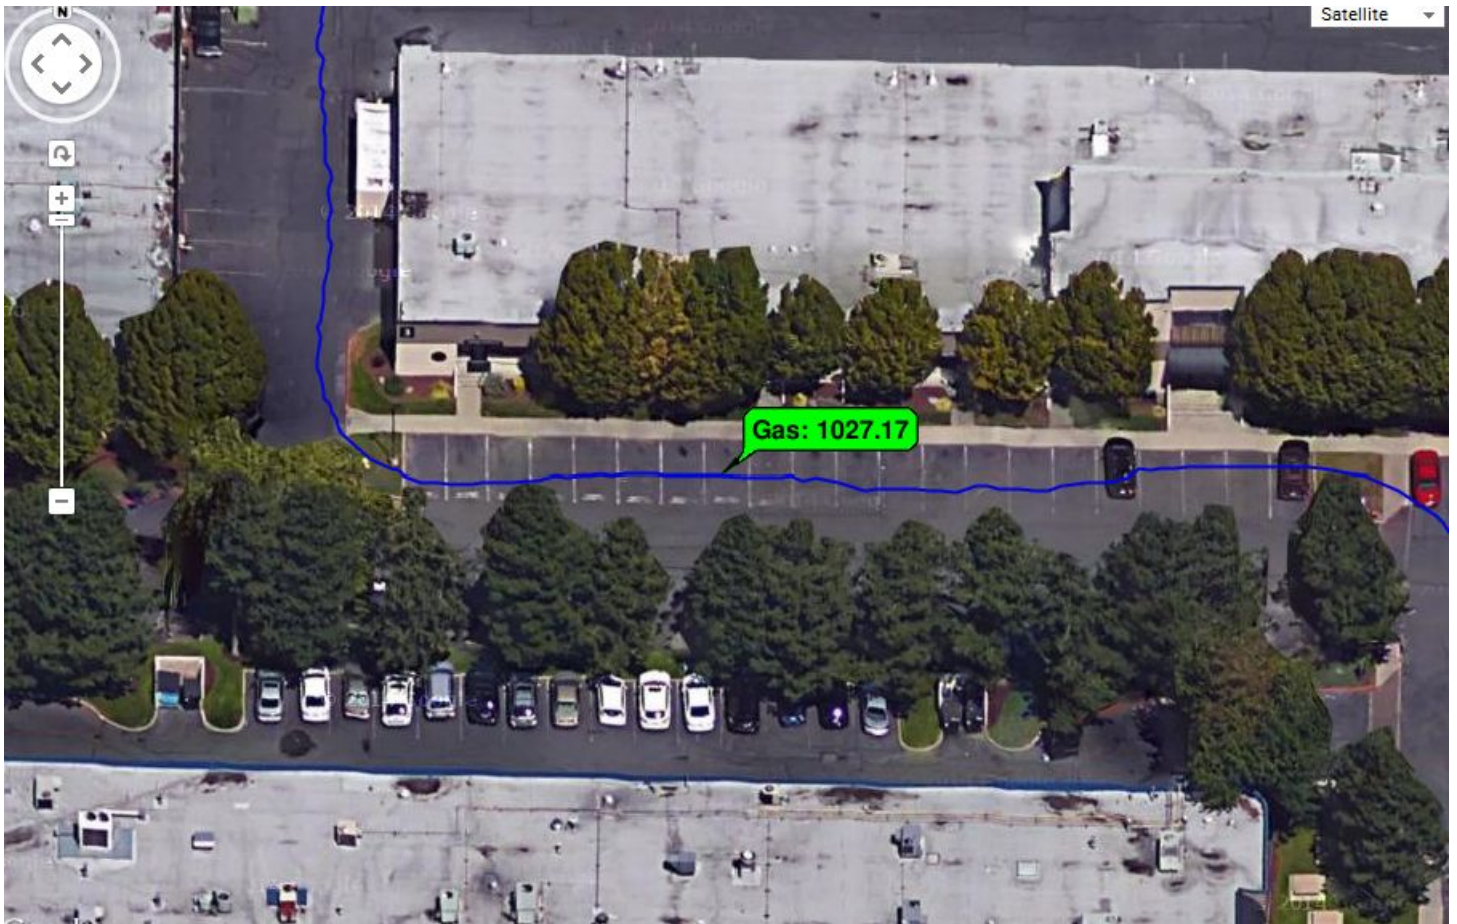
Map:

Detection	Time	Latitude	Longitude	Maximal vehicle speed, km/h	Maximal gas concentration, ppm
1	10:48:32.91	47.4419200	-122.2204400	13.6	1027.17
